Repair of the 10-inch Riser on the Subsea Gas Transmission Pipeline

Beta Offshore Production Complex, Platform Elly, Long Beach, California
Client: Beta Offshore

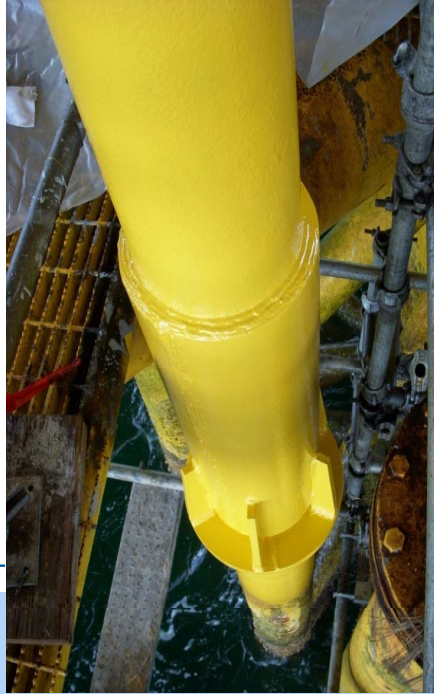
A “smart-pigging” of the 10-inch gas pipeline from Eureka to Elly indicated serious corrosion in one section of the riser pipe just below the 14 Deck, in the surf zone of Elly. In order to obtain full approval from the BOEMRE for the return to production of Eureka, Beta Offshore was required to repair and reinforce this section of “J” Tube and riser pipe.

- Evaluation of the “smart pigging” results
- Conducting of a UT inspection of the suspected area of corrosion and wall loss
- Design a reinforcement / repair plan to correct this deficiency to meet API 1104 and BOEMRE requirements
- Prepared the repair plan
- Designed the required structural support plan for the “J” Tube
- Negotiated the approved implementation with the BOEMRE
- Selected the API 1104 certified contractor
- Ordered materials and supervised installation of this fast track repair in accordance with API 1104
- Prepared final report for submission to the BOEMRE for their review and approval

This reinforcement / repair was performed during the low tide times, in rough seas and high winds, and still completed on time to facilitate the RTP of Eureka.
